A.1

THE NEW *Schoolfield* DISTRICT

EXISTING CONDITIONS *Report*

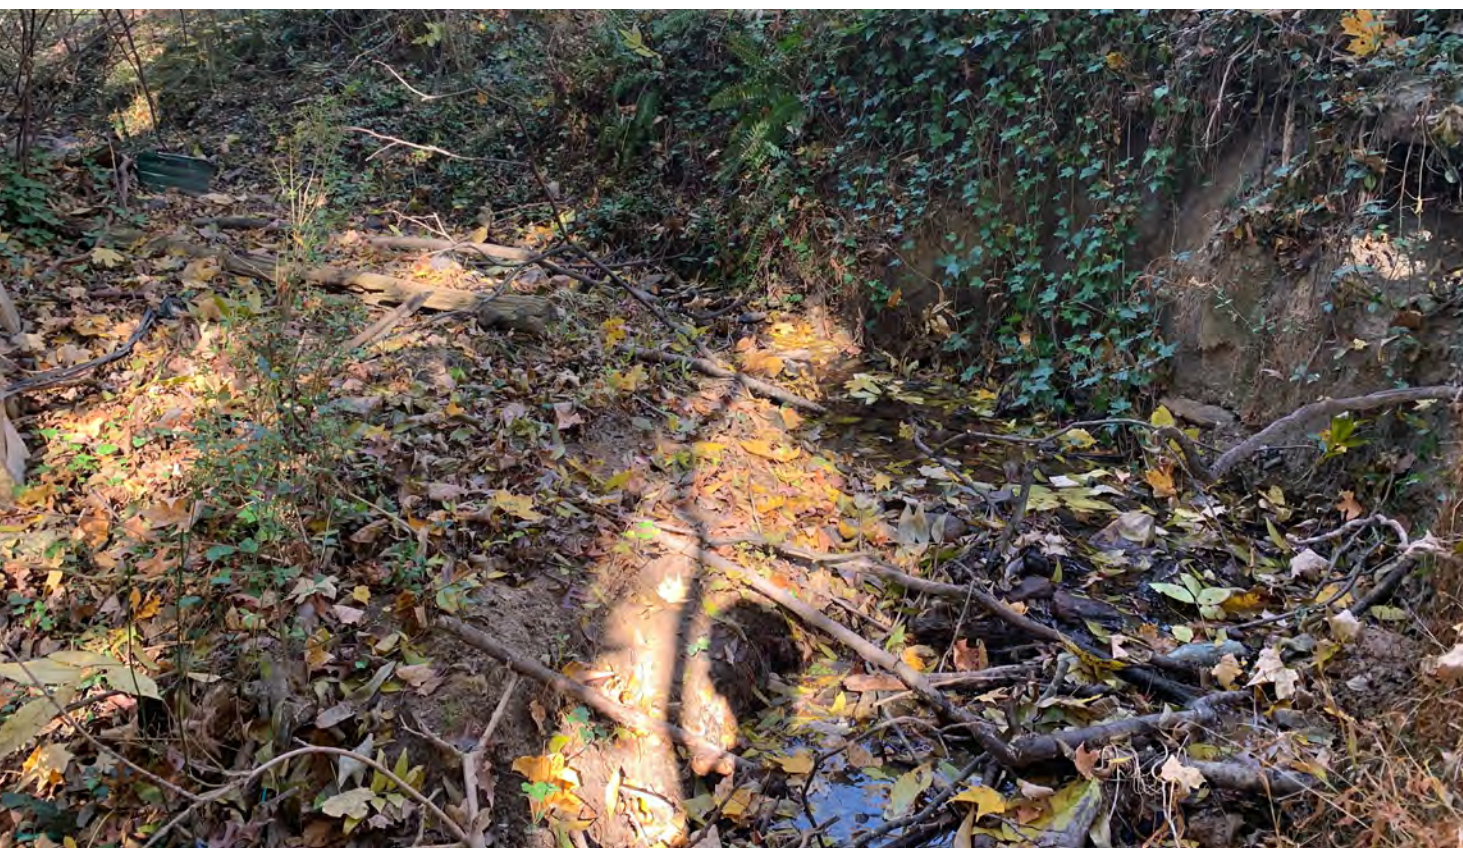
Tributary north of City Stream and Hylton Ave Park - steep, eroding stream banks and significant invasive species issues. (Source: Davey Resource Group)

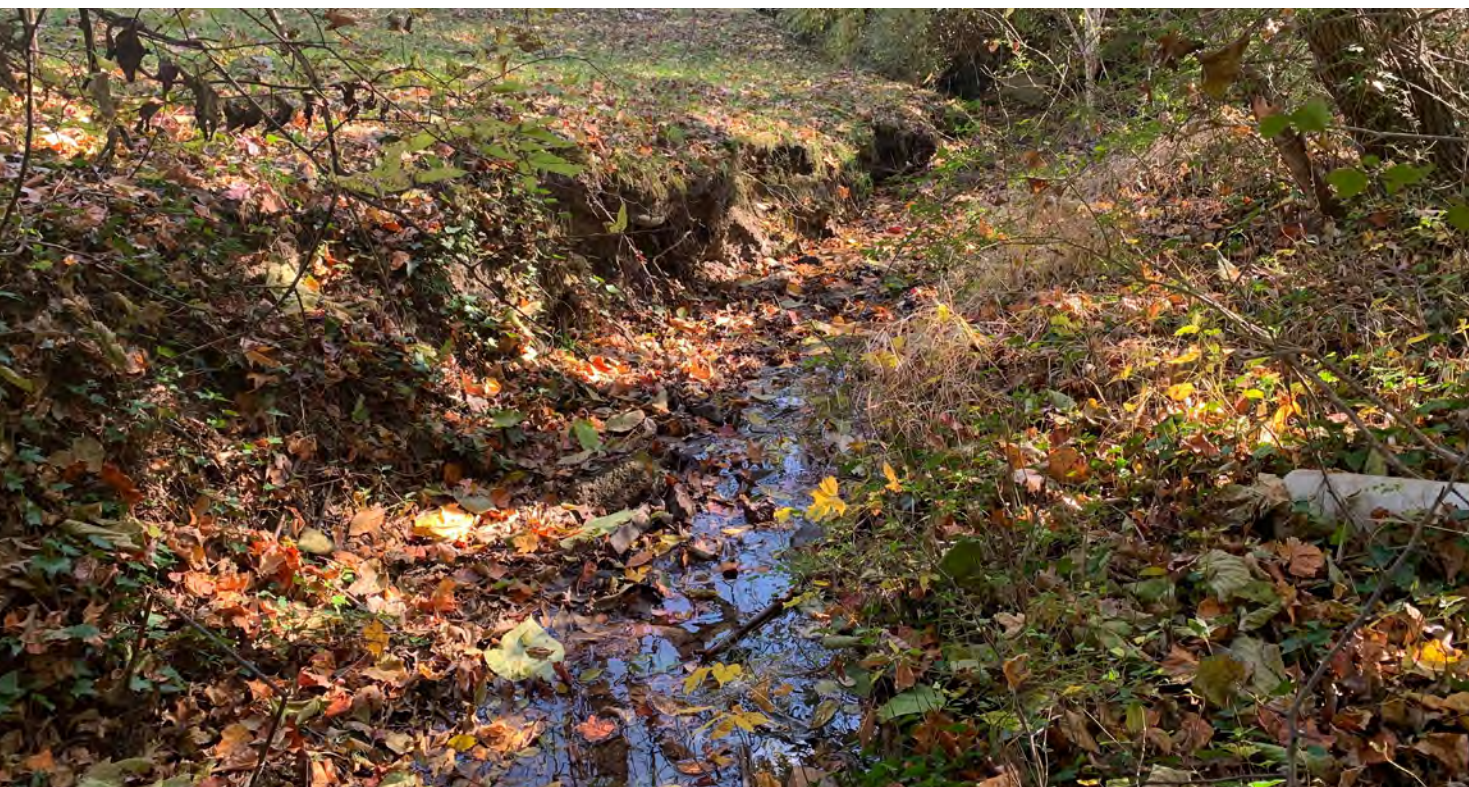
This image shows erosion occurring along the banks of the City Stream. (Source: Davey Resource Group)

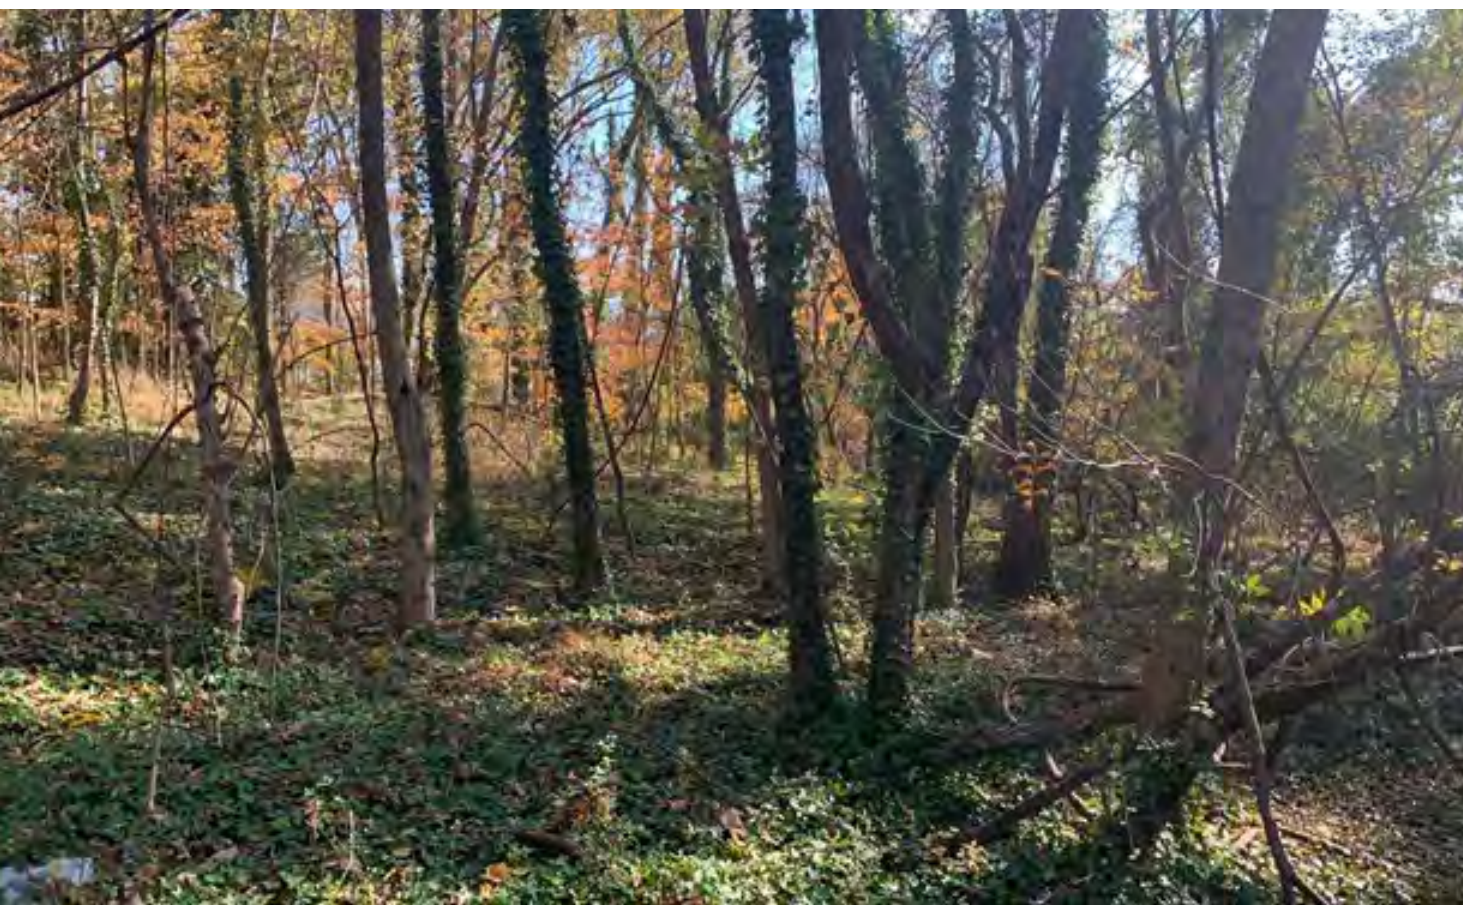
Photo of an area of woodland dominated by non-native invasive English Ivy and Wintercreeper. (Source: Davey Resource Group)

Non-native invasive (NNI) plant species proliferate in many of the vegetated areas throughout the study area. NNI plants are non-indigenous plants that cause damage to native ecosystems by easily out-competing native species for resources such as light and water. The result is diminished ecological value of the infested area due to displacement of beneficial native vegetation and the creation of monostands of unruly vegetation. Once established, these monostands serve as seed banks for the spread of NNI species into the surrounding areas or downstream in the watershed.

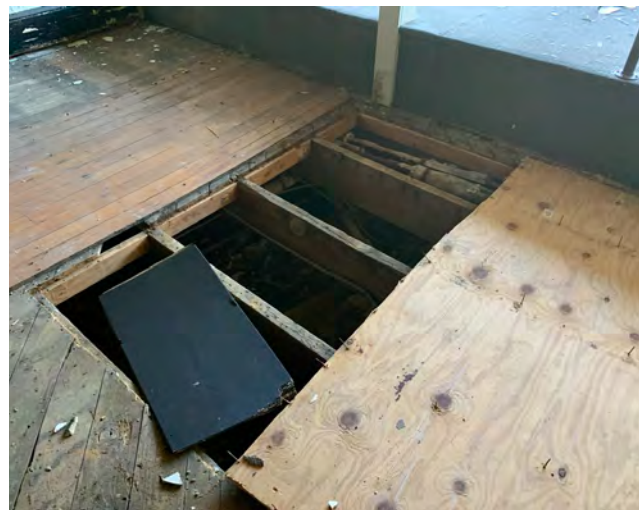
Typical Lower Level Floor Construction

The lower-level floor elevation is above street level and isolated exposed damaged areas indicate that the lower level is likely a framed timber floor over a crawl space. The condition of the floor framing was not visible but a check for water/fungal damage is advised (bottom right). At some

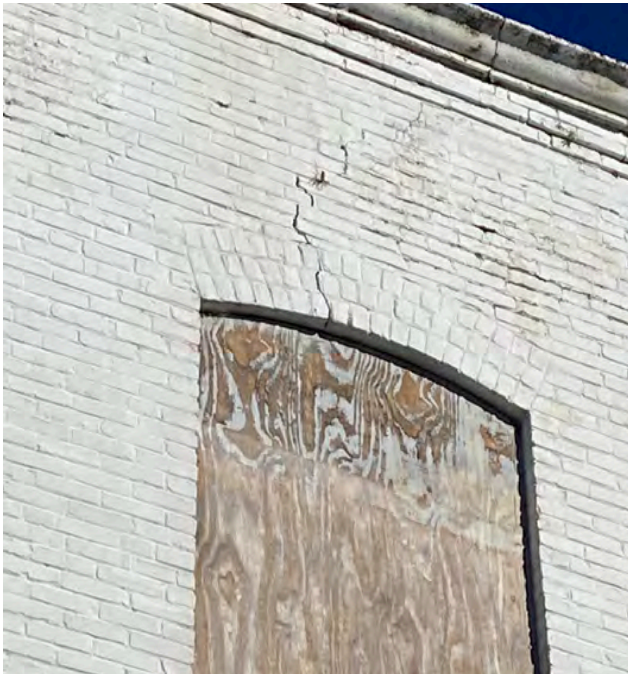
Masonry Settlement

point, the exterior masonry wall along West Main Street was significantly altered by removal of the lower half of the wall, and re-support of the remaining upper half of the wall with new steel beams and columns. This alteration allowed for the insertion of glazed storefront construction (left). The balance of the building's exterior walls are as originally built and bear at grade. The walls are in generally fair-good condition with isolated diagonal settlement cracks noted at arch lintels (left).
