A.1

THE NEW *Schoolfield* DISTRICT

EXISTING CONDITIONS *Report*

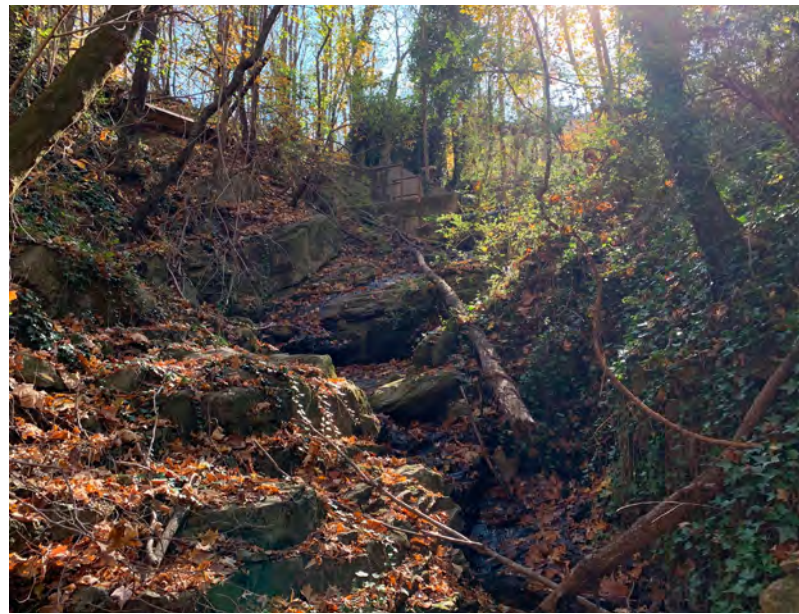
The “Casino Stream” near the end of Browder Ave drains the eastern portion of the casino property site (Figure 3). The stream’s main outlet channel begins at the northern portion of the commercial area and is characterized by an outfall cascade, bedrock channel lined with large woody debris and steep bank slopes. The main channel flows adjacent to powerline easements with a grass-lined corridor. Ascending pools and bedrock cascades provide oxygen to the stream throughout the channel reach. These geological influences limit opportunities for restoration, instead shifting the focus to preservation. This reach does have a high volume of trash from past mill activities and could benefit from its removal (items including appliances, household goods, etc.).

*Casino Stream - lower channel lined with large woody debris and steep bank slopes.
(Source: Davey Resource Group)*

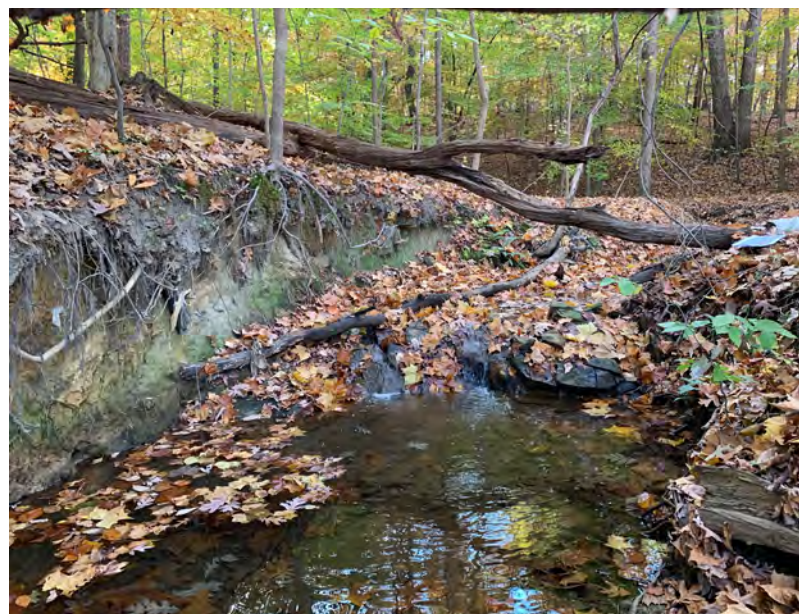
The “Western Stream” and “Trib 3” (Figure 3) begin their course along the border between a forested private parcel on the west and an undeveloped barren parcel on the east owned by the Industrial Development Authority of Danville. Tribs 2 and 3 collect stormwater from adjacent residential neighborhoods and the undeveloped lot on the southern end owned by the IDA, while the remainder of the stream is likely fed by runoff from upstream slopes. Although the majority of the Western Stream and its tributaries flow through undeveloped forested areas, the stream is still experiencing significant erosion—particularly in the upper reaches near the stormwater outfalls on tribs 1, 2, and 3 (see adjacent photos). The lower reaches of this area are largely stable and are suitable candidates for preservation and buffer protection. Steep slopes in the upper reaches of the drainage area are experiencing ongoing erosion just below existing outfall locations. These areas have bank heights in some areas of more than 15 feet. Restoration in the western stream corridor would likely focus on outfall stabilization strategies such as the installation of rock steps and boulder pools to stop erosion and dissipate energy, conveying stormwater down to the main channel where slopes are significantly flatter and natural bedrock features prevent base level change. Restoration in these areas has the potential to generate significant pollutant removal (nutrient/sediment) credits.

Western Stream - Stream erosion and eroded banks continue toward the bottom of the stream where it meets Route 29. (Source: Davey Resource Group)

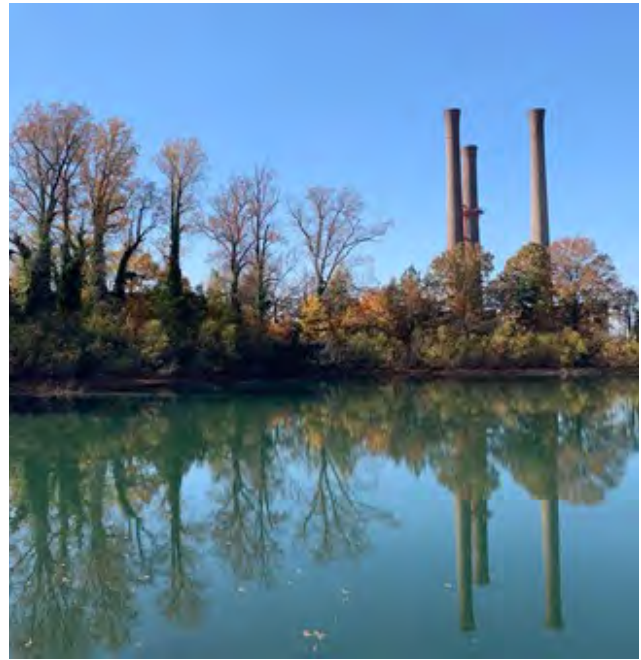
Photo looking east on a mapped pond along Park Ave. (Source: Davey Resource Group)

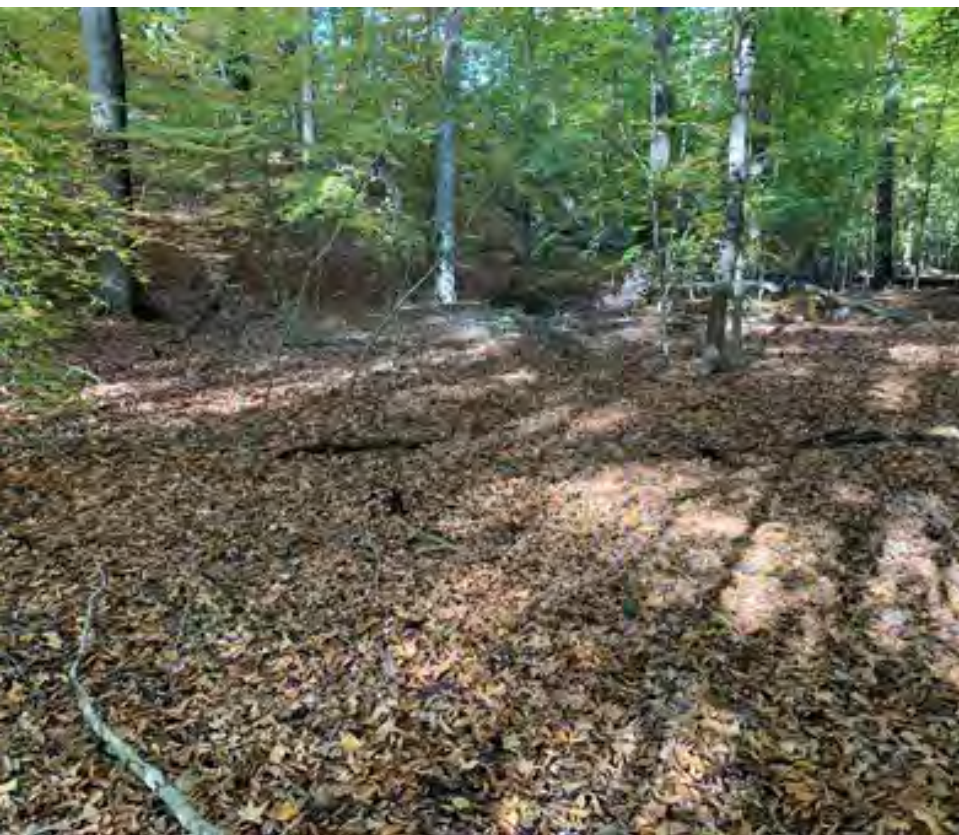
Photo of an assumed palustrine forested wetland area in the western area of the site limits. (Source: Davey Resource Group)

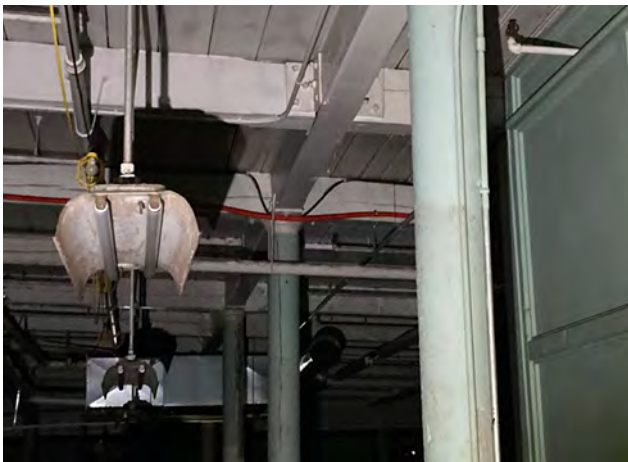
Typical Beam and Girder Connection

In the original part of the building, the roof is framed with heavy timber sections and is composed of timber plank decking spanning approximately 7 ft. – 6 in. to 8 x 12 timber beams. The beams span approximately 15 ft. and frame to 8 x 12 girders. The timber girders span approximately 15 ft. are in turn supported by 8 in. diameter timber columns. The end connections between the beams and girders are formed with metal angles on each face, secured with heavy lag bolts drilled into the face of each member (below). The girders are connected to 8 in. diameter timber columns, with decorative cruciform shaped cap plates fitted to the tops of the tapered columns (bottom right).

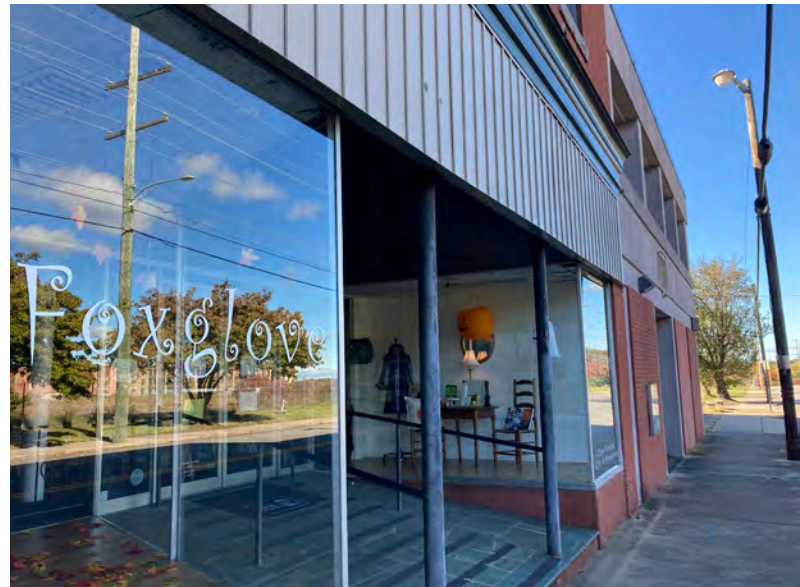
Typical storefront entrance

Each section at Level 1 has dedicated front and rear access. Currently these entrances utilize ramps or steps. These do not meet accessibility requirements; historic building provisions of IEBC may permit the existing condition to remain in place without modification, if approved by the local authority having jurisdiction.

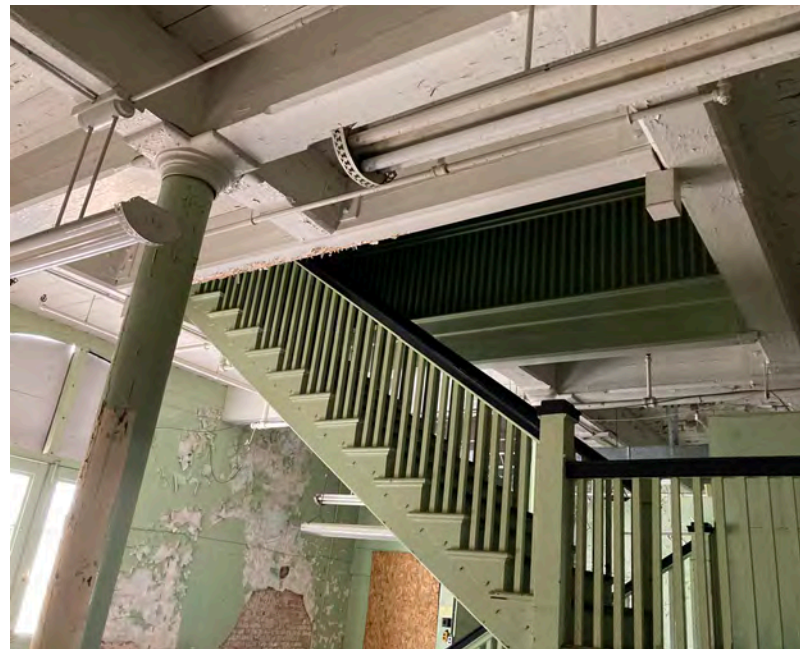
Existing north stairs

is between Section 1E and 1F. There is a dedicated stair in Section 1A to Section 2A. The vertical circulation at the stairs do not meet current code requirements for guardrails. Historic building provisions of IEBC may permit the existing condition to remain in place without modification, if approved by the local authority having jurisdiction (left).

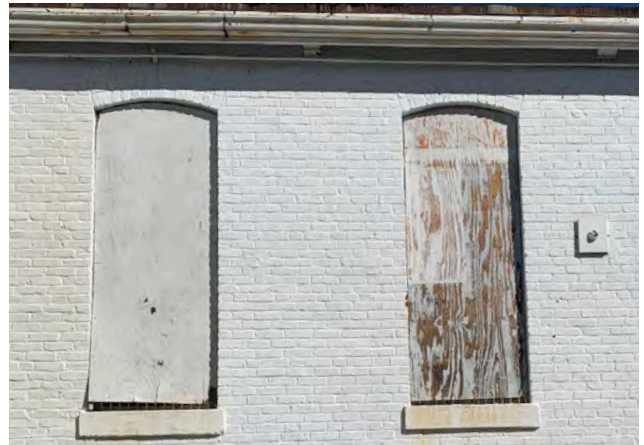
Typical widow with rowlock brick arch and limestone sill

The perimeter currently has ample existing openings with the average window size being 3'x7'. The condition of the windows was obscured but all the glazing appears to require replacement. The windows could be restored to original operating condition with storm windows for natural ventilation.

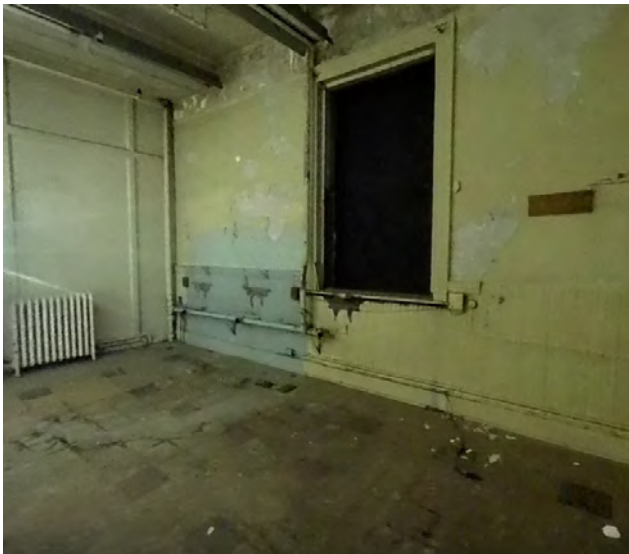
Finishes in Section 2B

Level 2 has much of the original wood trim from at door, windows and millwork. The original floor finishes appear to be intact in Section 2A and 2C, but have deteriorated in Section 2B. Section 2D was not visible. Most of the original plaster appeared to be intact where visible, but with peeling paint throughout. Original radiators exist in most spaces. The original wood columns taper at the top and do not have a base.

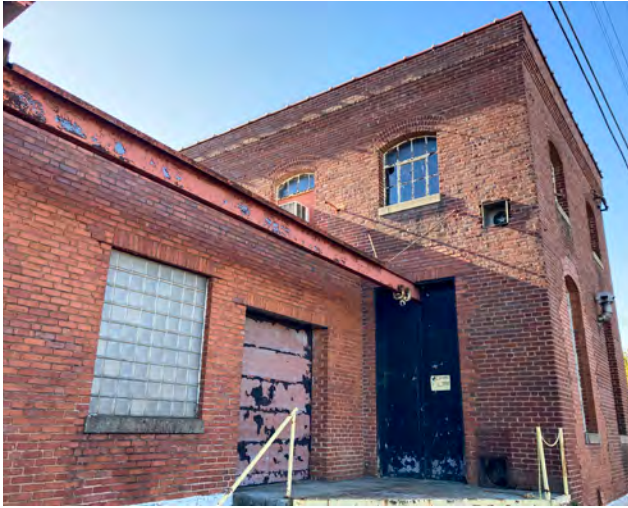
North Office Wing and Receiving Addition

The north office (north portion of Section A) is a two-level brick clad structure that abuts the filtration gallery. The building is framed with reinforced concrete floors and stairs and a steel framed roof. The exterior brick walls include brick arched lintel window openings and terra cotta copings. A later brick-clad receiving and loading dock addition is adjacent to the office section to the east and includes an open steel-framed canopy and jib crane. The walls of these sections are in fair condition.

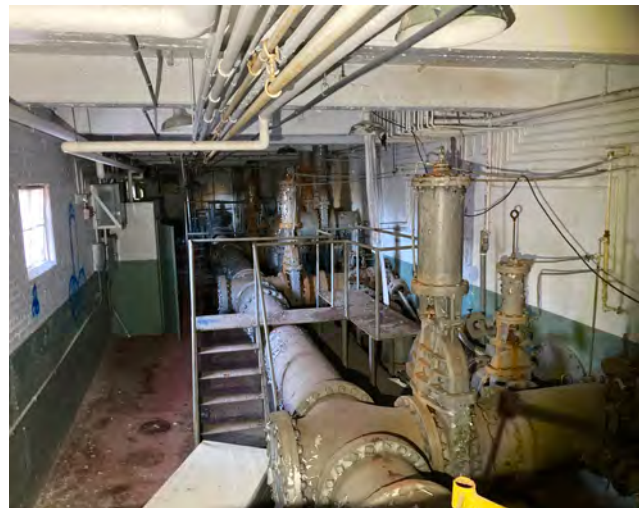
Lower Filtration Gallery - South Wing. Note the taller floor to ceiling height in the south wing.

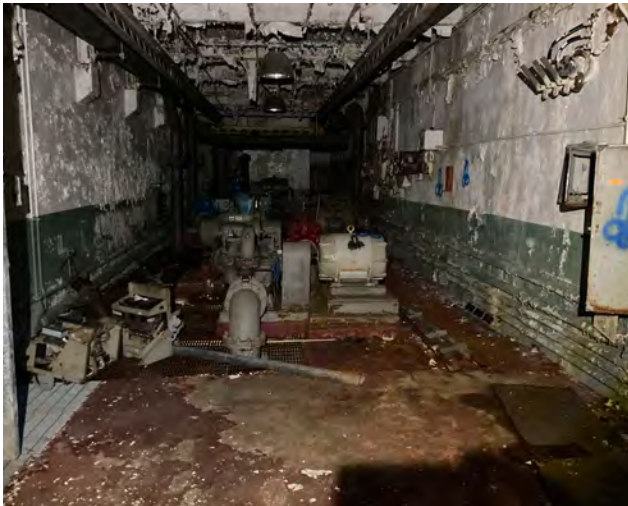
Sub-level tunnel from filtration gallery to the pumping gallery - looking west towards the filtration gallery. South wall of the covered storage tank to the right.

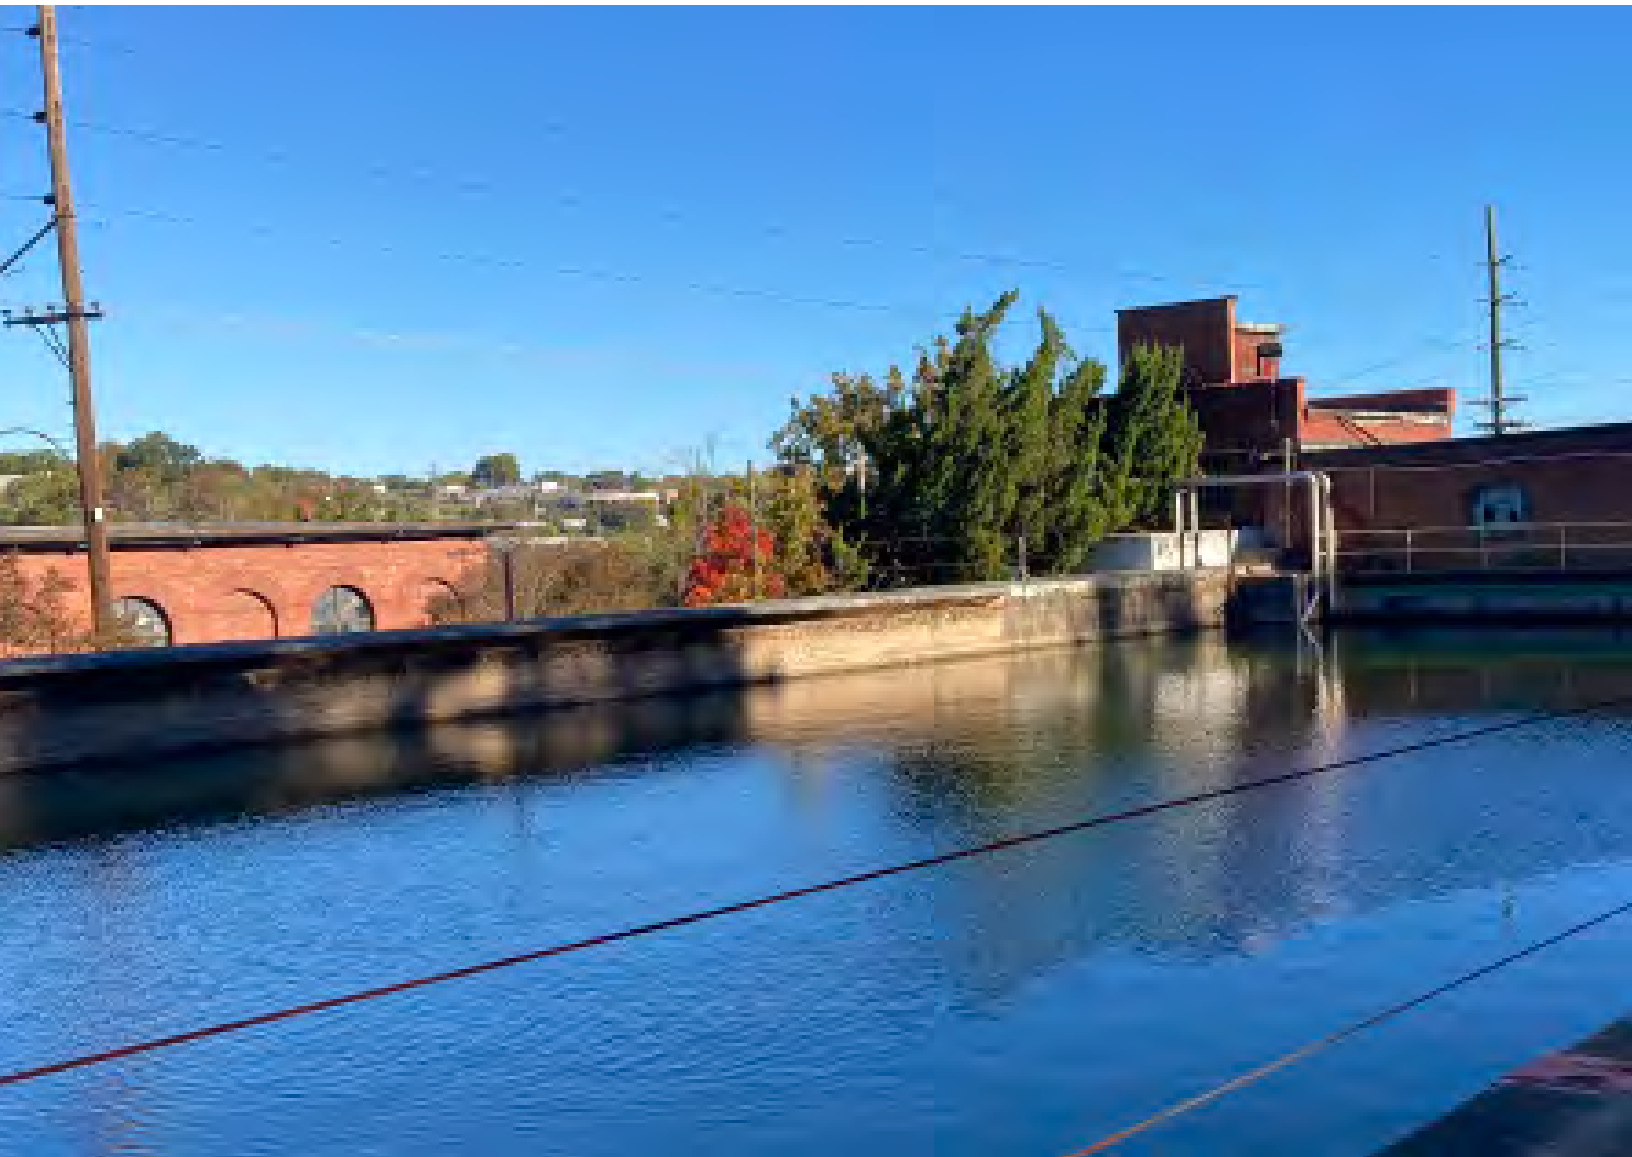
North settling tank looking northeast toward the Dan River

The outdoor settling tanks to the west of the filtration gallery occupy a large area, as noted above. These tanks are formed with reinforced concrete walls and appear to be approximately twelve feet deep. Likewise, the smaller covered storage tank (Section B) to the east of the filtration gallery is formed with thick reinforced concrete walls. These are robust structures with side walls and foundations that could likely support two-three levels of new commercial construction that would face the Dan River.

Prior to re-use of the filtration gallery and settling tanks, a survey should be conducted to identify any residual sludge, sediments or contaminants that need to be removed.

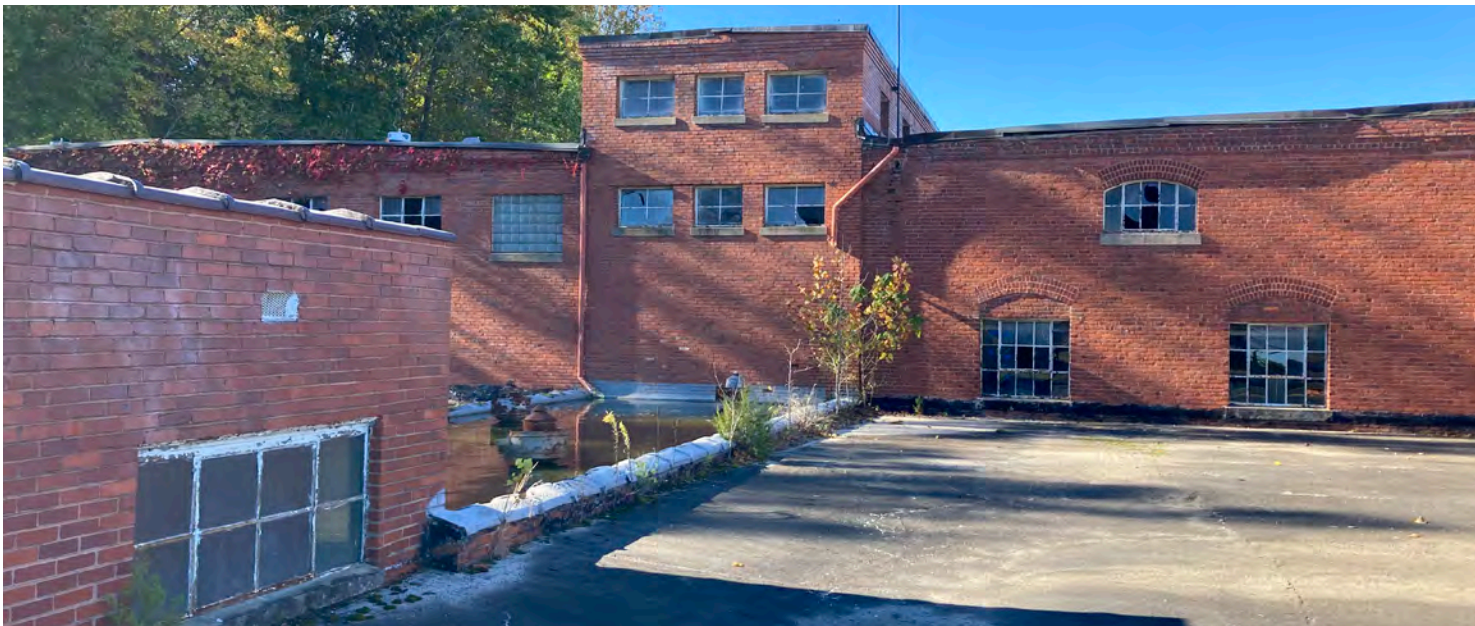
A good portion of the glazing in every window is damaged. All the windows would require replacing and potential upgrading for a more energy efficient envelope. The windows could remain operable for natural ventilation during the more mild seasons

- **Section A:** There are large perimeter openings at Levels 2 and 3. On the northside most of the original window frames and sash remain. The windows have arch rowlock headers with soldier brick work and stone sills in most places. Many of the windows have an operable awning component. On the south and central sections on the same levels about half of the windows have their original windows and the windows are set in openings with stone sills and metal lintels rather than arch row lock. The missing glazing has been infilled with glass block. The original windows have an operable awning component.

Fenestration at the perimeter

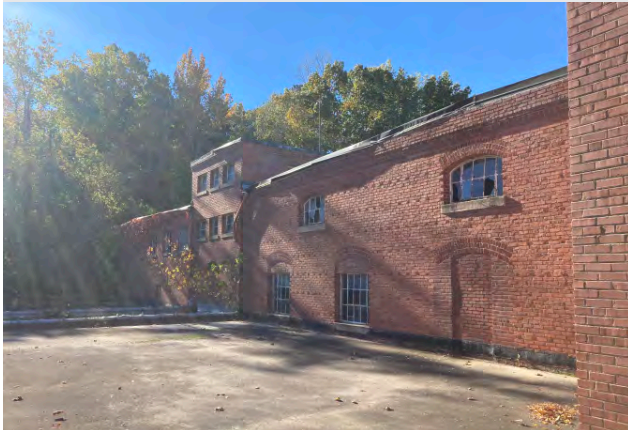
Exterior masonry at Section A

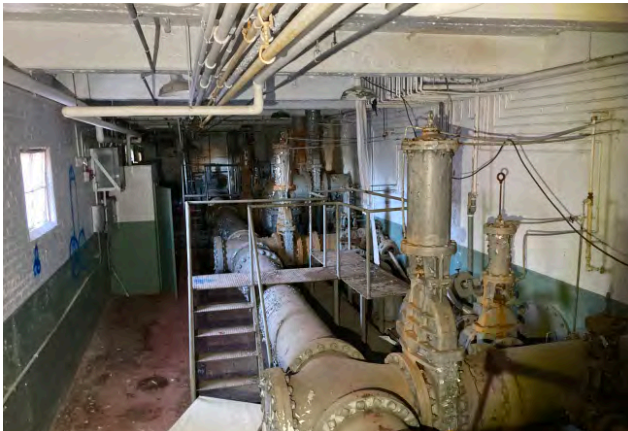
Dormant pumping system

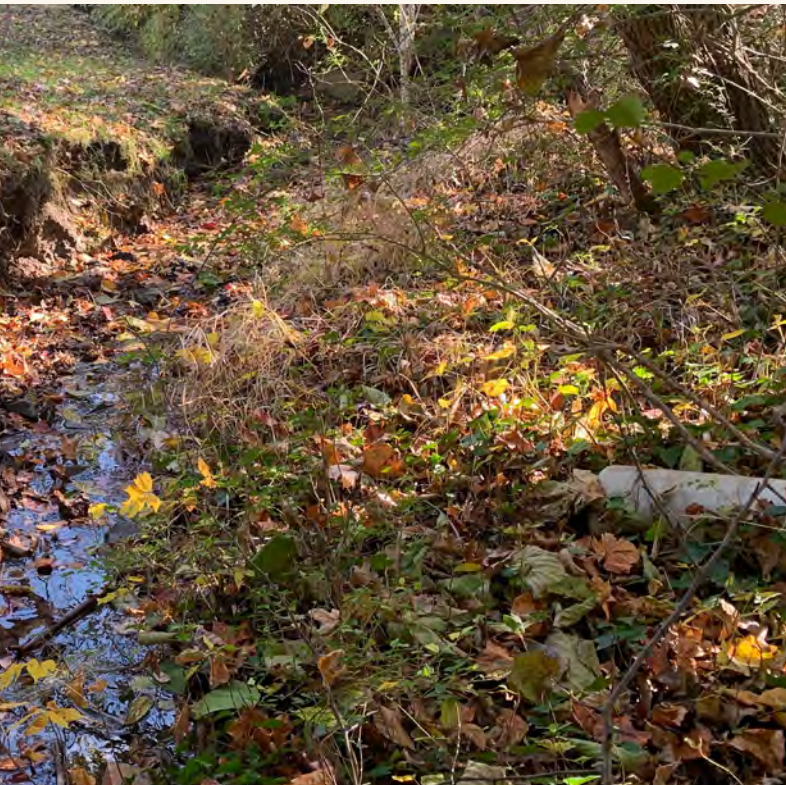
This image shows erosion occurring along the banks of the City Stream. (Source: Nathan Staley)

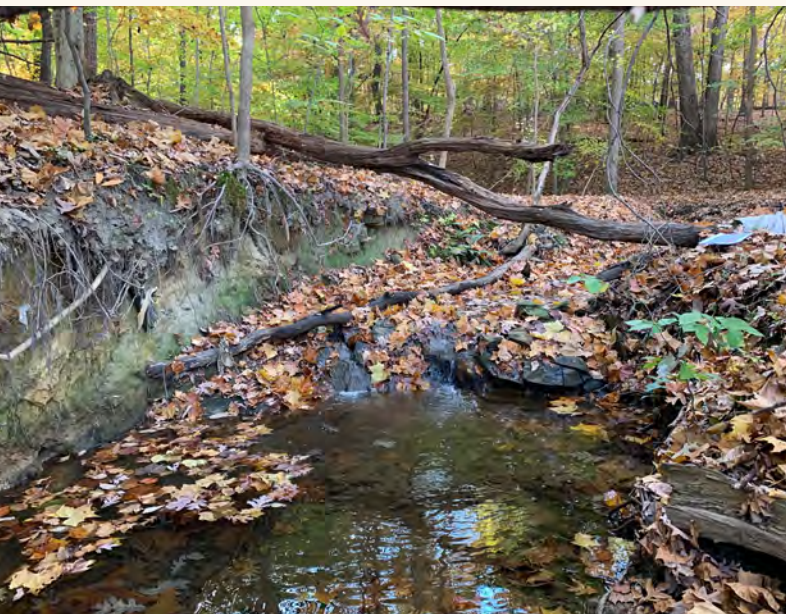
Western Stream - Stream erosion and eroded banks continue toward the bottom of the stream where it meets Route 29. (Source: Nathan Staley)
